STS-112
FLIGHT READINESS REVIEW

September 17, 2002

Ground Operations

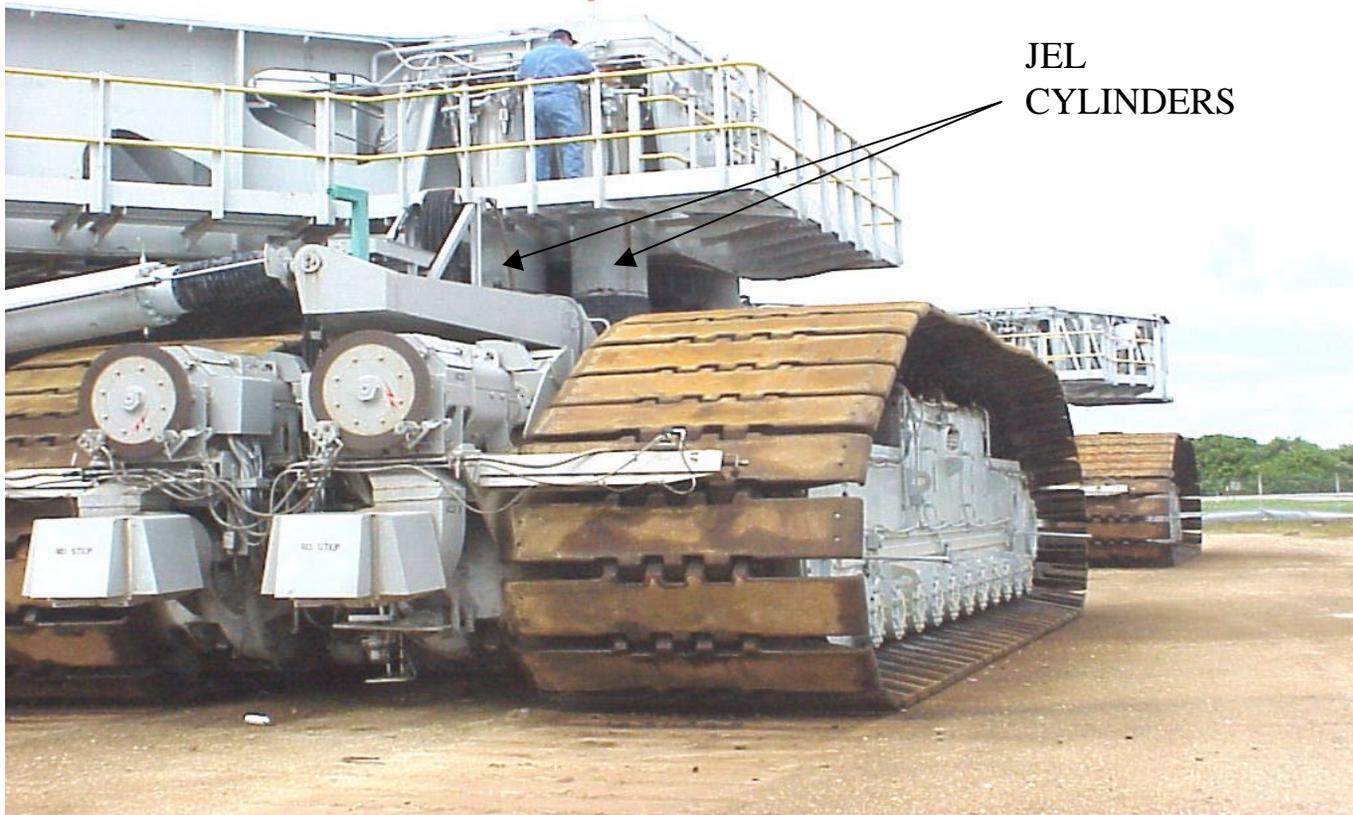
CT JEL Cylinder Locations

- Two JEL (Jacking, Equalization, and Leveling) Cylinders were removed from CT-2 as the beginning of a planned refurbishment program
 - Disassembly revealed that three of the four spherical bearings were severely cracked
- **Inspection of all 32 cylinders showed 30 of 64 bearings were cracked or broken**

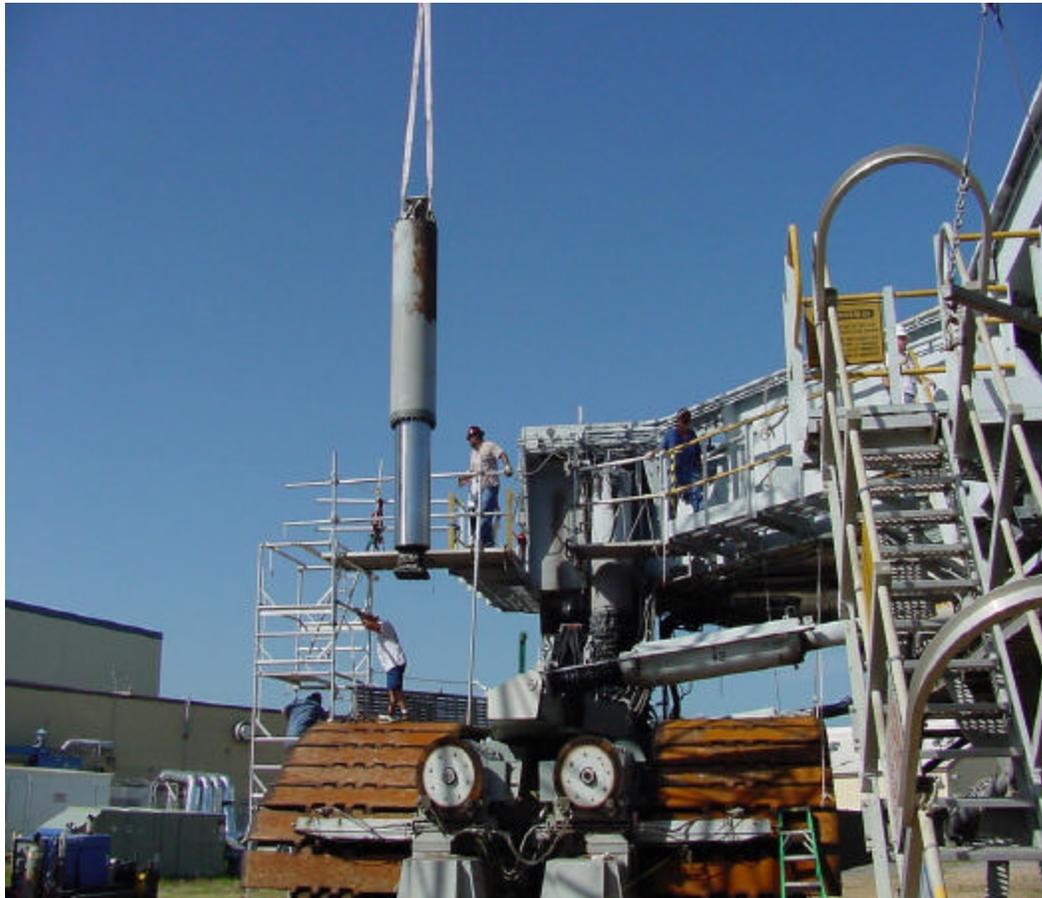
JEL Cylinder Removal

- The spherical bearings on each end of the JEL cylinders are in the primary load path
- Each JEL cylinder weighs approximately 10,000 pounds, and can produce 1.6 million pounds of thrust
- All 32 cylinders (16 on each crawler) are originally-installed equipment that have been in service for 37 years
- Routine preventive maintenance (lubrication, corrosion control, etc.) has been performed over the service life per specification

- Current design determined to meet load requirements
- New and undamaged bearings installed with enhancements
 - New lubricant utilized with superior properties for application (Caterpillar Desert Gold Grease)
 - Method developed to mitigate rotation and augment press fit using Loctite 660, Quick Metal
- Repair meets original Crawler Transporter design and cycle life
 - Allows ample time for Design to evaluate modern bearing designs for possible upgrade (2020 support)
- CT-1 repair is In-work – ECD 11/02
 - Available for emergency use within 48 hours
- CT-2 Repaired, supported STS-112 roll to Pad and is Operational

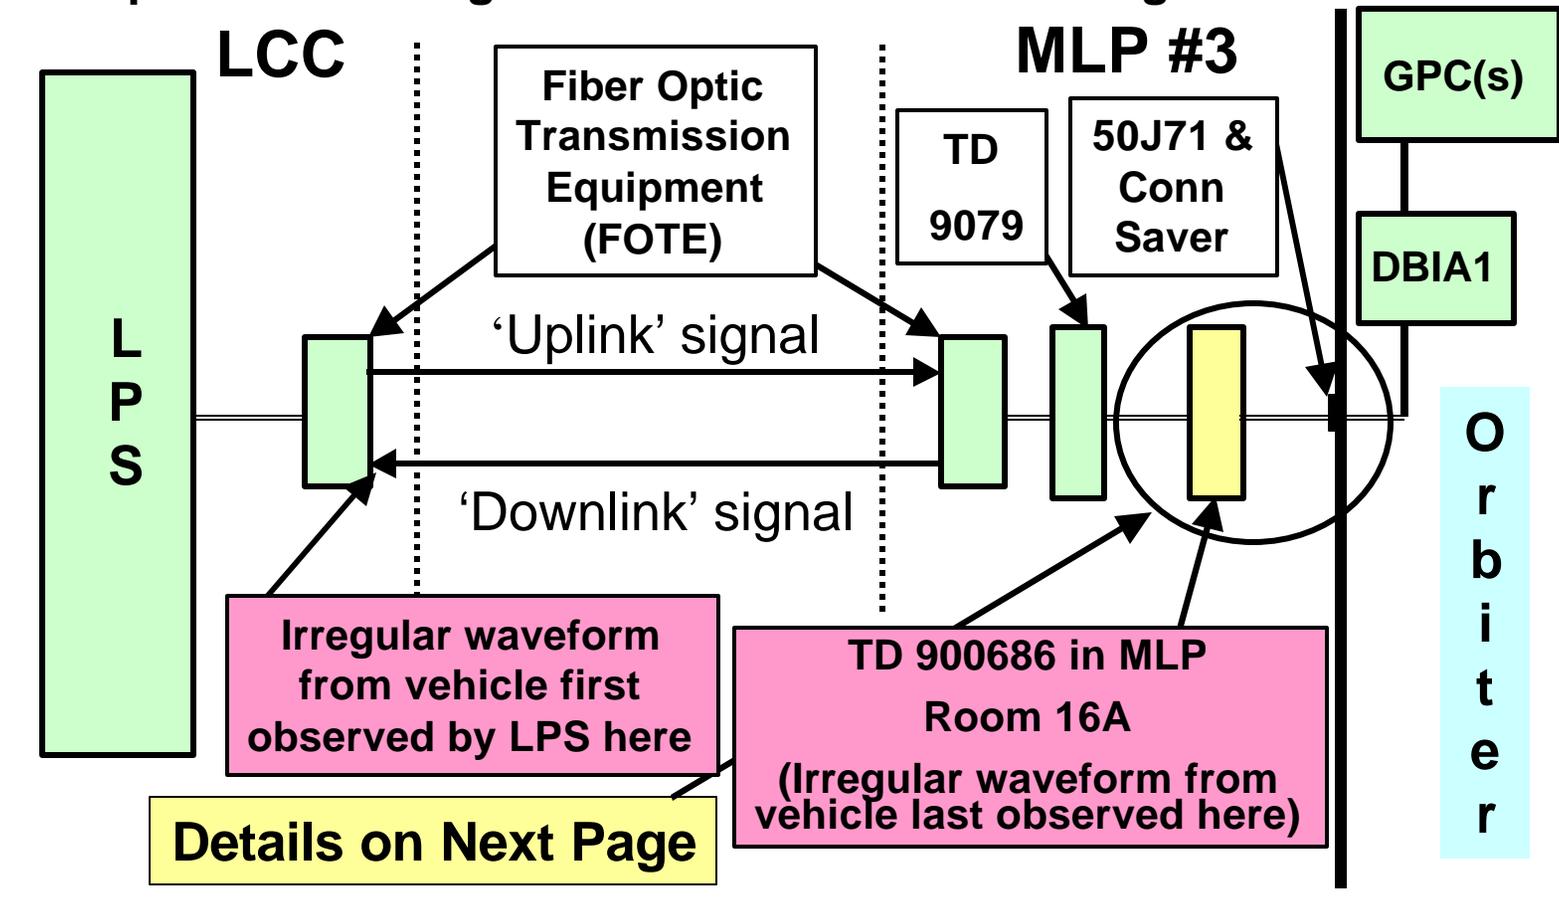
Simplified Line Diagram for LPS to Vehicle Configuration

- Observation
 - During STS-110 Launch Scrub Turnaround on 4/4/02 an uncommanded auto-switch from LDB-1 to LDB-2 occurred
 - After the completion of hazardous safing operations an attempt to switch back to LDB-1 also failed, indicating problem was still present
 - STS-112 is using the same MLP 3 as STS-110
- Concerns
 - Loss of Ground Polling capability to the vehicle could result in increased hazards and the inability to command the vehicle should both LDB paths fail at the same time

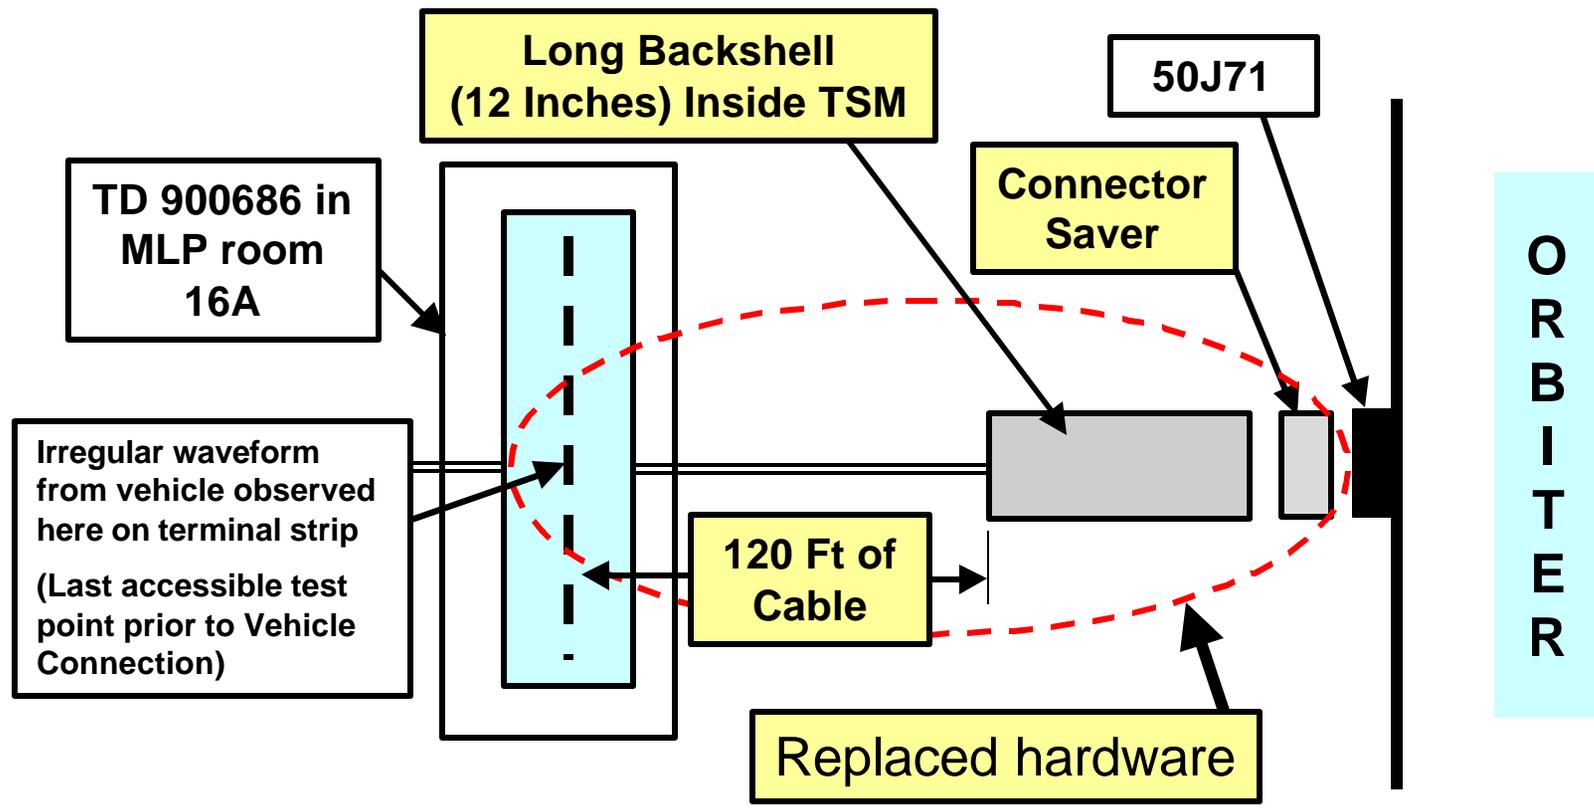
Detailed Line Diagram for LPS to Vehicle Configuration

- Actions Taken
 - Troubleshooting included monitoring of the LDB-1 signal
 - At the OLSA rack in MLP3 from the orbiter at the 9079 terminal distributor (TD) signal was distorted
 - On the 900686 TD on MLP3 (Last connection point prior to the T-0 umbilical) signal was distorted
 - LDB-1 signal was disconnected at 900686TD and a termination resistor was placed across the orbiter side of the data bus
 - Signal distortion remained present from the orbiter side, exonerating all ground transmission paths except the 50J71 T-0 Connector and associated 120 ft cable to the T-O

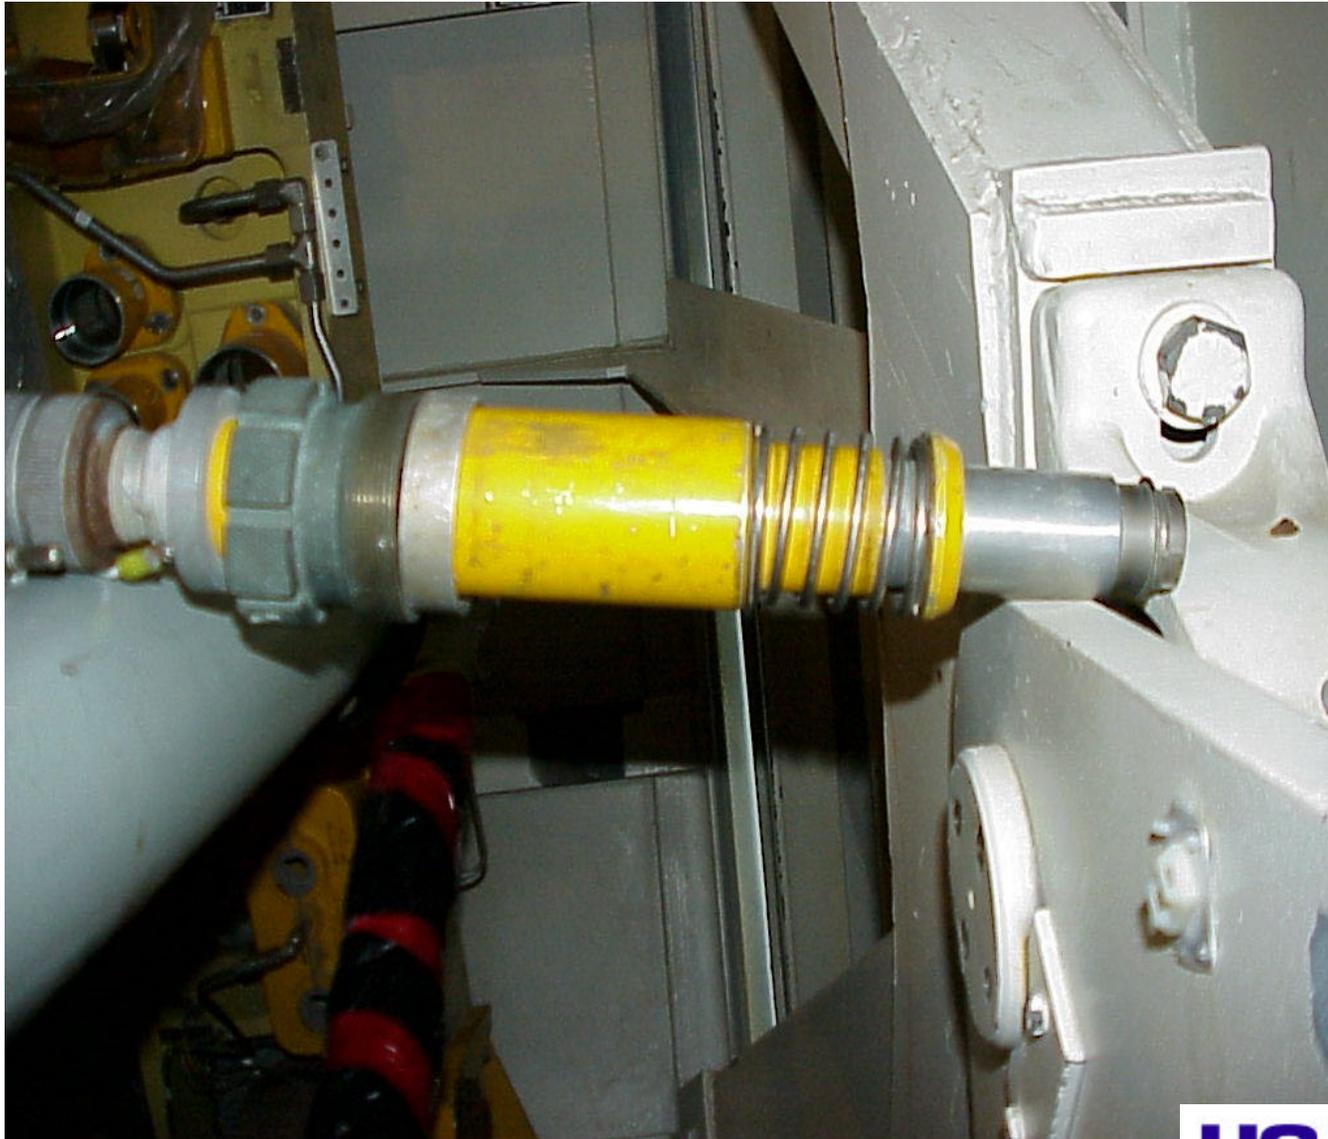
GO-BU-25

- Failure Analysis (Cont'd)
 - The connector saver, MLP3 connector 6009W21P1 and 2 ft of cable were cut off from the 120 ft cable and sent to the NASA MAB Lab for failure analysis
 - Preliminary Lab report shows extensive corrosion/contamination on the pins in this connector, including those carrying the LDB1 signal 'GG' & 'HH'
 - Major contaminants were composed of Al, Si, Cl, Ca, and 'Copper corrosion'
 - The fine gauge wire was also confirmed near but not touching pins 'GG' and 'HH' (See next few pages for photo's of debris)
 - The connector saver, connector, and cable stub were subjected to an Insulation Resistance Test and continuity testing with wire contamination present
 - Passed all testing conditions at (500V IR @ 100 Mohm)
 - Could not duplicate the exact LDB1 failure signature

- Failure Analysis (Cont'd)
 - Could not duplicate the exact LDB1 failure signature
 - Pin corrosion was verified to be non-conductive
 - X-Ray results confirmed the nominal pin to socket contact length
 - 3mm for the 22 gauge wire connectors
 - Destructive testing and additional failure analysis are on-going
 - Further identify the nature of the corrosion
 - Identify a better cleaning solution/material and process for the future of these typical connections
 - Cleaning to date has been with IPA applied by brush

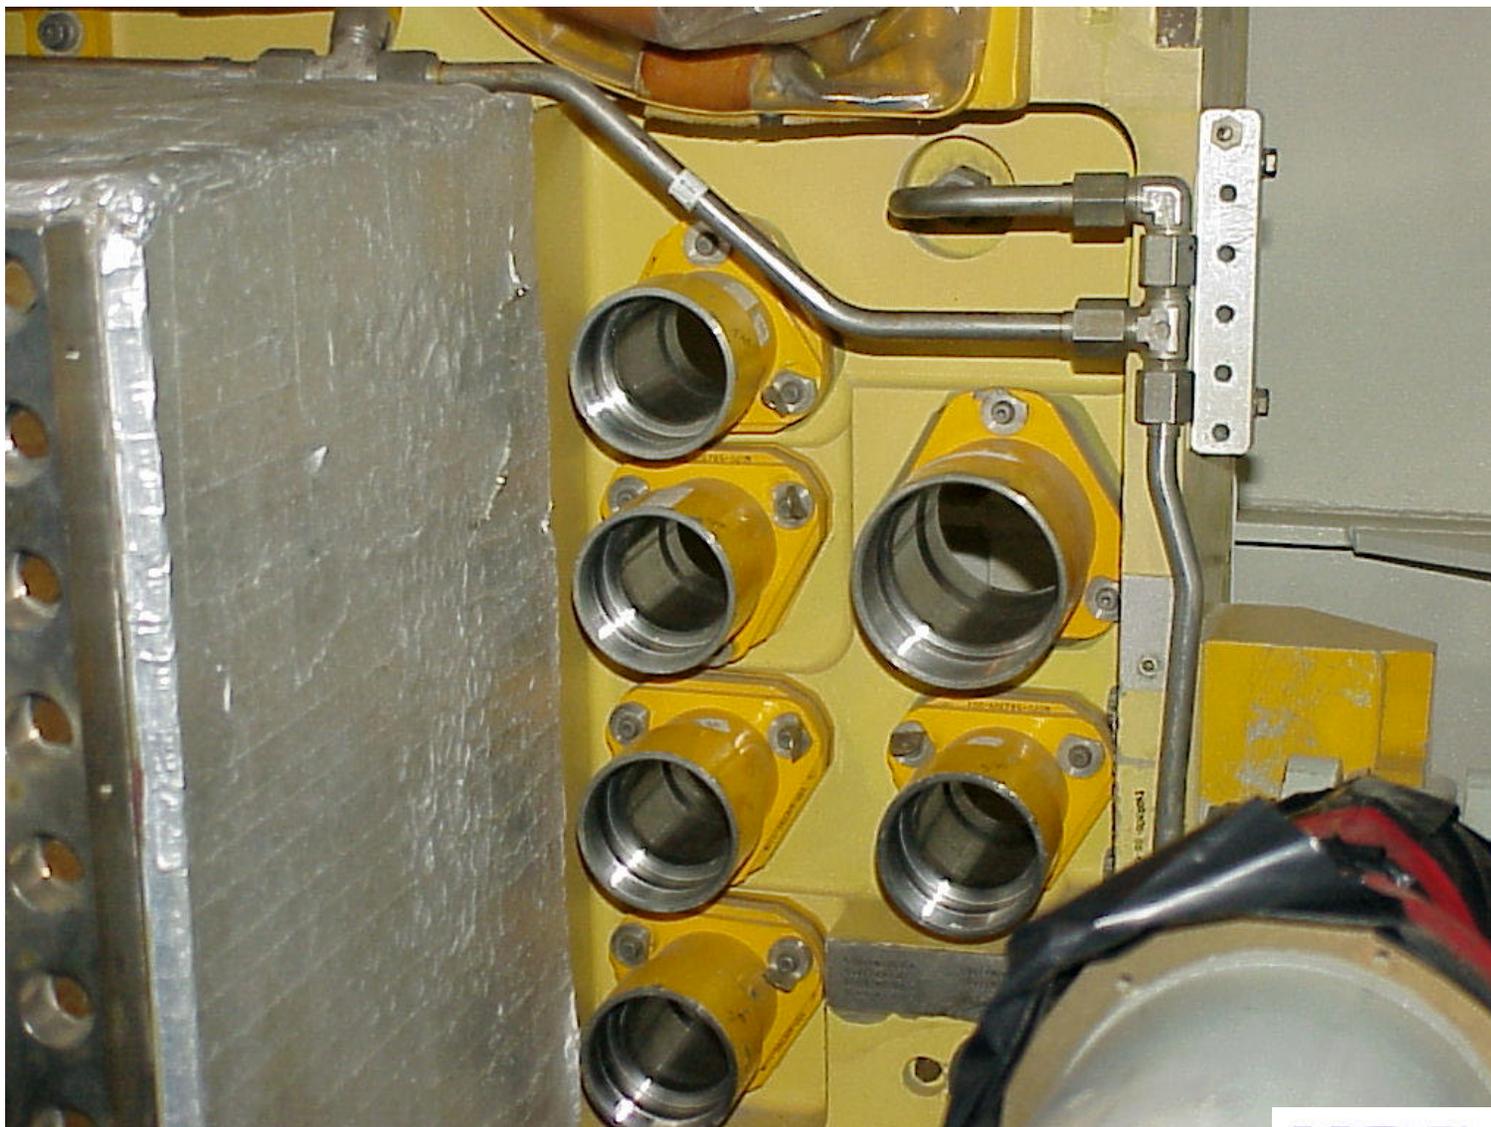
Inside TSM- looking toward vehicle
GO-BU-26

- Possible Causes
 - An Intermittent copper path problem in the wiring between the 900686 TD and GSE Connector 6009W21P1
 - An intermittent in the onboard data bus wiring between the T-0 receptacle 50J71 and DBIA-1 in Av Bay 4
 - An intermittent electrical problem in the Data Bus Coupler (DBC) linking LDB-1 to DBIA-1
 - An intermittent electrical problem in the portion of the DBIA-1 that handles the LDB communication between LPS and the onboard GPC's
 - An Intermittent copper path problem between the outboard sockets on the vehicle connector 50J71 and the pins on the Connector Saver
 - An Intermittent copper path problem between the outboard sockets on the Connector Saver and the pins on GSE Connector 6009W21P1

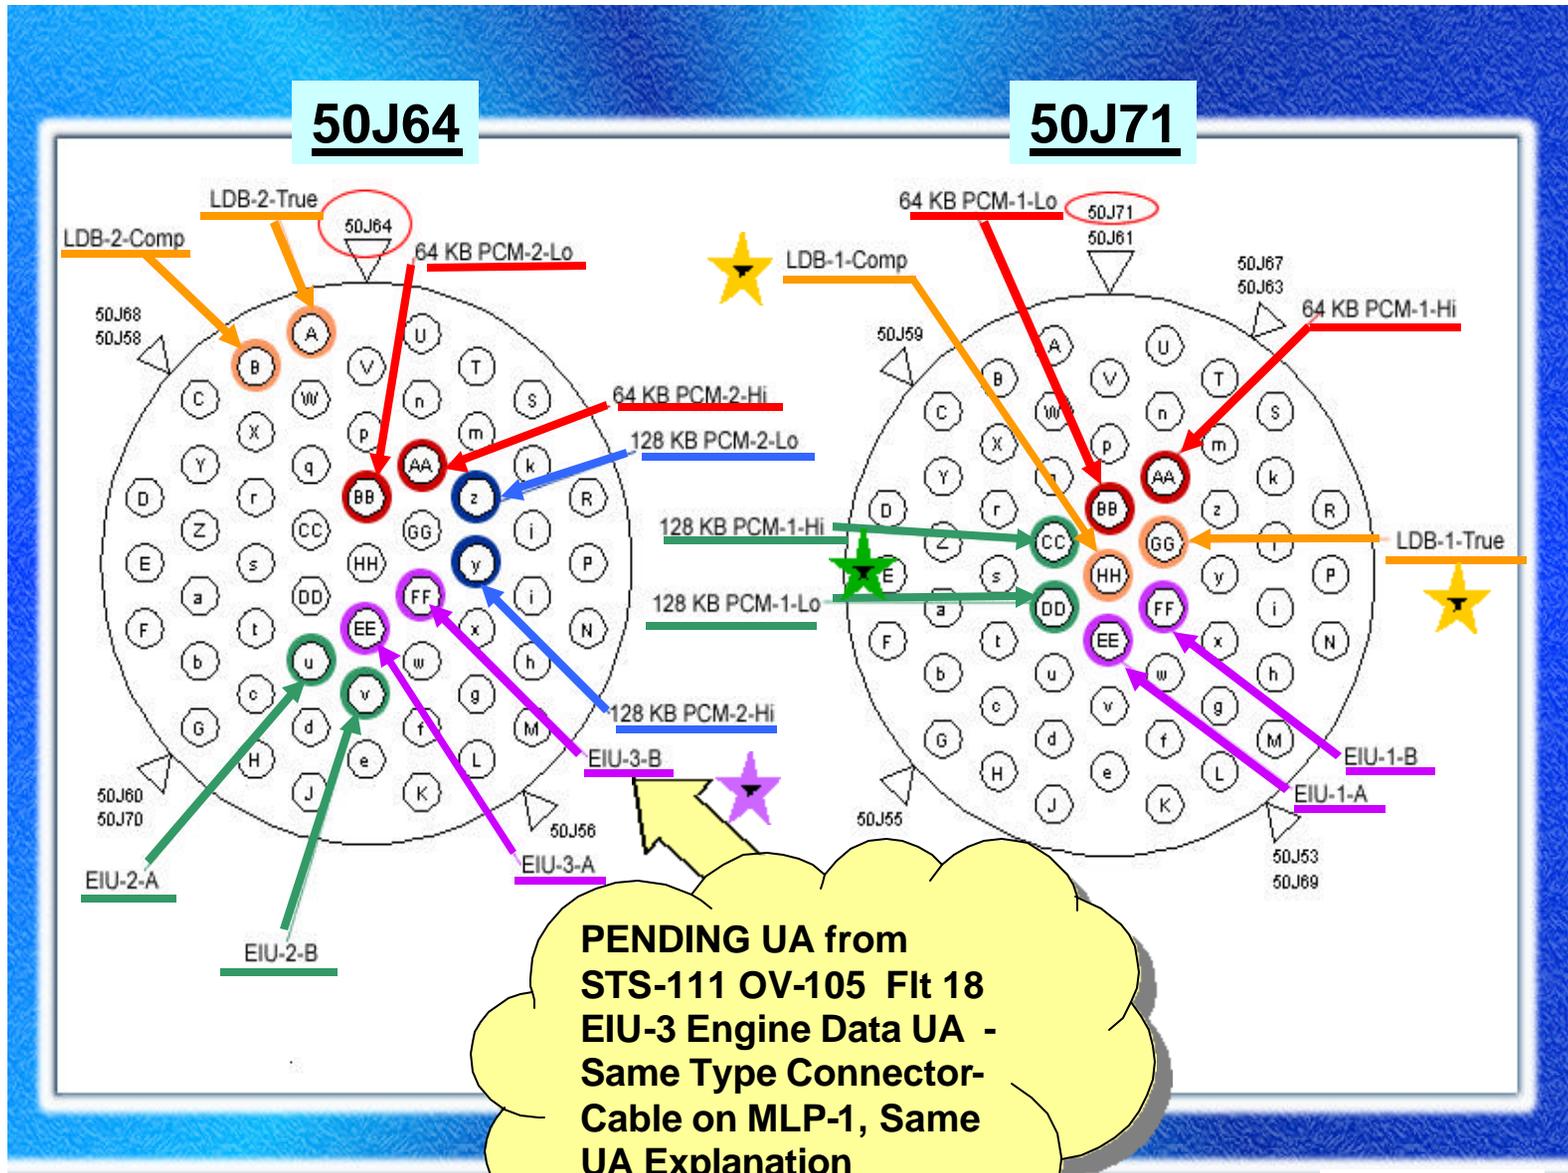
50J64/71 PIN LAYOUT

- Cause is believed to be the corrosion found by the MAB lab on the pins of the GSE Connector 6009W21P1
